## Low-velocity impact behaviour of woven laminate plates with fire retardant resin

Marzio Grasso<sup>a,\*</sup>, Yigeng Xu<sup>b</sup>, Amit Ramji<sup>b</sup>, Gang Zhou<sup>c</sup>, Andreas Chrysanthou<sup>d</sup>, George Haritos<sup>a</sup>, Yong Chen<sup>d</sup>

The understanding of the damage mechanisms for woven laminate plates under low-velocity impact is challenging as the damage mechanisms at the interface of adjacent layers are dominated by the fibre architecture. This work presents an experimental investigation of the behaviour of woven glass and carbon fibre composite laminates in a matrix of fire retardant resin under low-velocity impact. The performance is evaluated in terms of damage mechanisms and force time history curves. Six impact energy levels were used to test standard plates to identify the type of damage observed at various energy levels. Scanning electron microscopy (SEM) along with C-scans were used to characterise the damage. It has been observed that in woven composites, the damage occurs mostly between the fibre bundles and matrix. As the impact energy increases, the failure involves extended matrix cracking and fibre fracture. Moreover, due to the fi

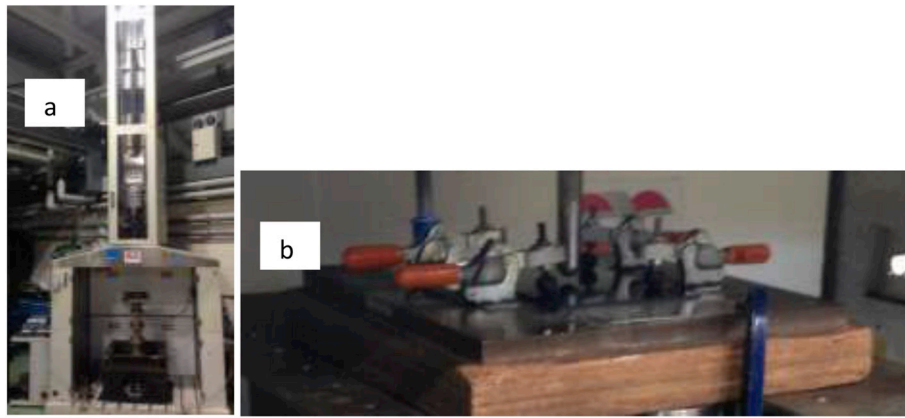
Fig. 1. Drop-weight tower used for the low velocity impact testing: a) the drop weight machine, b) the holding mechanism for the sample in the drop tower.

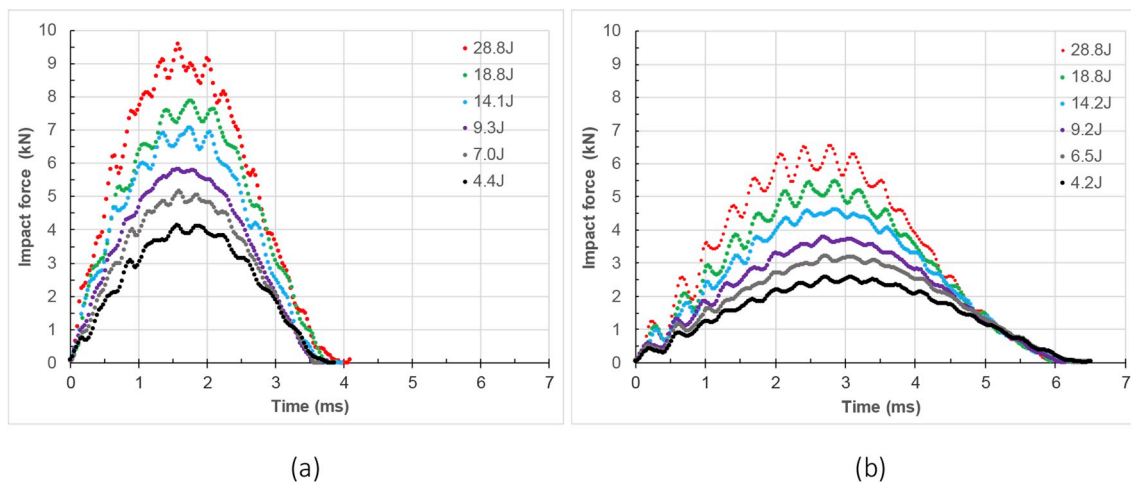
Fig. 2. Impact force – time curves of (a) woven carbon fibre and (b) woven glass fibre composite laminates.

Fig. 2 shows the impact force-time histories of the woven composite laminate plates under the low-velocity impact at six energy levels.

The general trend of the dynamic response is similar for the two woven plates made of different reinforcement fibres. The impact duration is independent of the impact energy level. The profile of the impact force history is symmetrical [24] about the peak impact force and can be

described by a sine function. This is in contrast to that observed with unidirectional composite laminates where the force-time curve is shifted towards the loading phase when impact damage is introduced [15]. The fluctuations of the impact force about the sine wave profile are primarily due to elastic wave responses and vibration of the specimen and are repeatable for replicate tests [15]. At low-impact energy, indentation as illustrated in Fig. 3 is the main damage mechanism and the level of the force fluctuation on the loading phase is similar to that on the unloading phase. At high-impact energy when other damage mechanisms are activated, the force fluctuation on the loading phase increases while the unloading phase is much smoother.

The force-time history curves in Fig. 2 show no noticeable sudden load drop for the woven plates with both fibre types. This observation is different from that for unidirectional composite laminates where a sudden load drop is commonly used to identify the delamination threshold load due to specimen stiffness loss as a result of laminate level damage. The results of the present study are consistent with the observation of Giannopoulos et al. [26] who were not able to identify a delamination threshold load from the filtered impact force time history curve of a woven composite plate. The low-velocity impact tests performed on woven composites by Kim and Sham [9] also showed no load drop nor slope changes until the load reached a maximum.

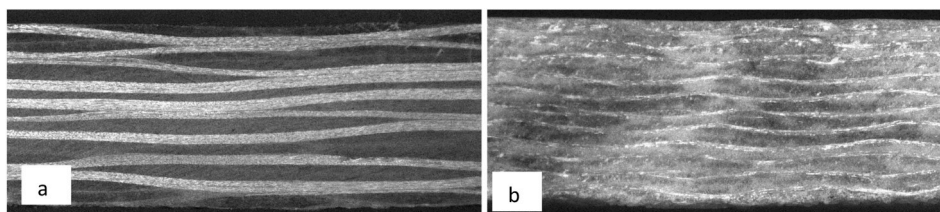
Fig. 3. Cross-sections showing the indentation of a) carbon fibre sample tested at 10 J and b) glass fibre sample tested at 5 J.

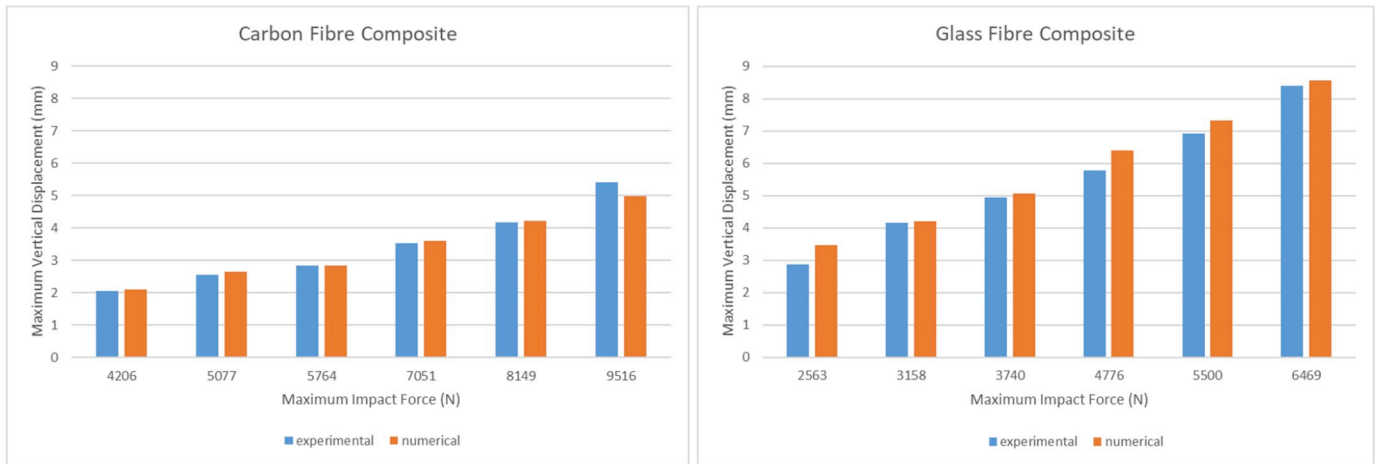
Fig. 4. Comparison of the experimental and theoretical maximum deflection of a) carbon fibre and b) glass fibre samples.

where E is the equivalent elastic modulus,  $\nu$  is the Poisson's ratio and h is the thickness of the plate. Using Eq. (1) and the maximum load values reported in Tables 3 and 4, the maximum deflection was derived and compared with the experimental values. Fig. 4 shows good agreement of the maximum deflection values between the experimental results and the theoretical predictions using Eq. (1).

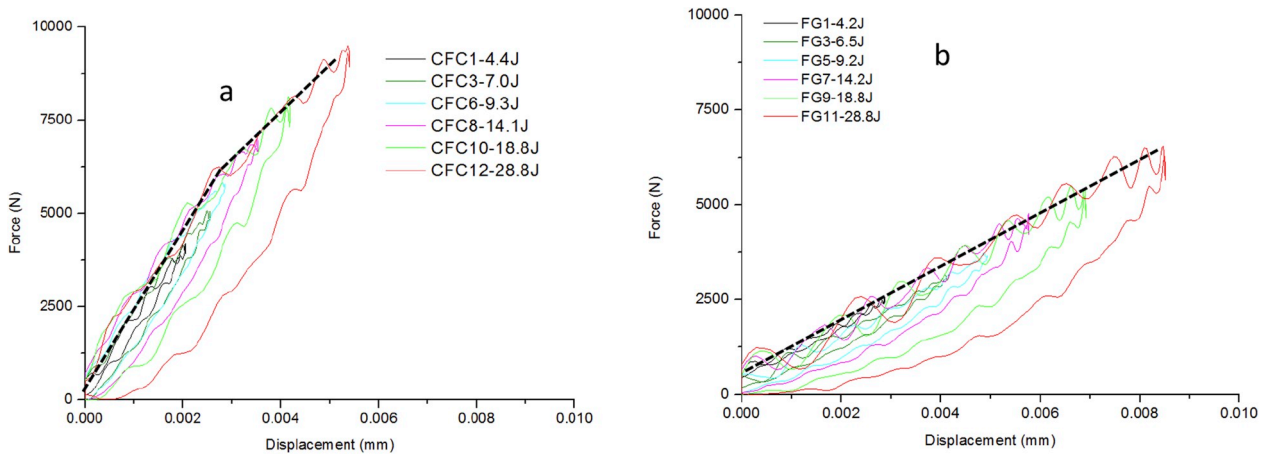
Fig. 5. Impact force – displacement curves for a) woven carbon fibre composite laminates and b) woven glass fibre composite laminates (the dotted lines show the change in stiffness observed for the carbon fibre composite).

Fig. 5 shows the impact force-displacement histories of the woven composite laminate plates under low-velocity impact of the six energy levels. The load drop or change of slope of the load-displacement curve may indicate nominal stiffness reduction due to the introduction of damage [8,27,28]. It is however, worth noting that for both the woven carbon fibre laminate plate and the glass fibre laminate, there is no noticeable load drop of the loading phase even at the highest impact energy of 28.8J. However, the load displacement curves for the carbon composite show a change in the slope around 6500 N (Fig. 5a). As discussed in the next paragraph, SEM analysis of samples tested at higher energy, the change in slope could be linked to fibre fracture and delamination. Similar behaviour was reported by Giannopoulos et al. [26] for CFRP material with fire retardant properties was tested under low velocity impact. The force-time history curves did not show any load drop. However, a change in the slope of the force displacement curves was observed around 4.2 kN with nominal thickness of cured laminates of 6.5 mm. Using the same approach the load drop for the material tested in this work is around 6.5 kN for the carbon fibre composite. The values for the glass fibre composite cannot be identified since there is no change in the slope of the force displacement curve (Fig. 5b).

There is no hysteresis in the loading and unloading phases for the woven carbon fibre plate under 4.4J impact and the woven glass fibre plate under 4.2J impact, indicating there is no noticeable energy absorption through damage during the impact event. As the impact energy level increased, the unloading curve became well-separated from the loading curve indicating that the specimen absorbed a significant fraction of the impact energy through local indentation and other damage mechanisms. The slope of the loading phase under high-impact energy levels, however, remains the same as the one under low-impact energy levels.

The change in slope is observed in the force-displacement curves for the carbon fibre and it is not observed for the glass fibre composite. The analysis of the damage mechanisms observed at different energy levels provides a potential justification for the above observation. The damage causing the change in stiffness in the carbon fibre composite is fibre fracture at the bottom face and is observed at high impact energy. In the glass fibre composite, fibre fracture appears at lower impact energy (<7.5J) compared to the carbon composite. The change in the stiffness affects the glass fibre composite plates and it is promoted by the stretching of the fibres due to the deflection of the plate. The deflection of the plates is responsible for the failure of the crossing fibre bundles at the contact areas (Fig. 11).

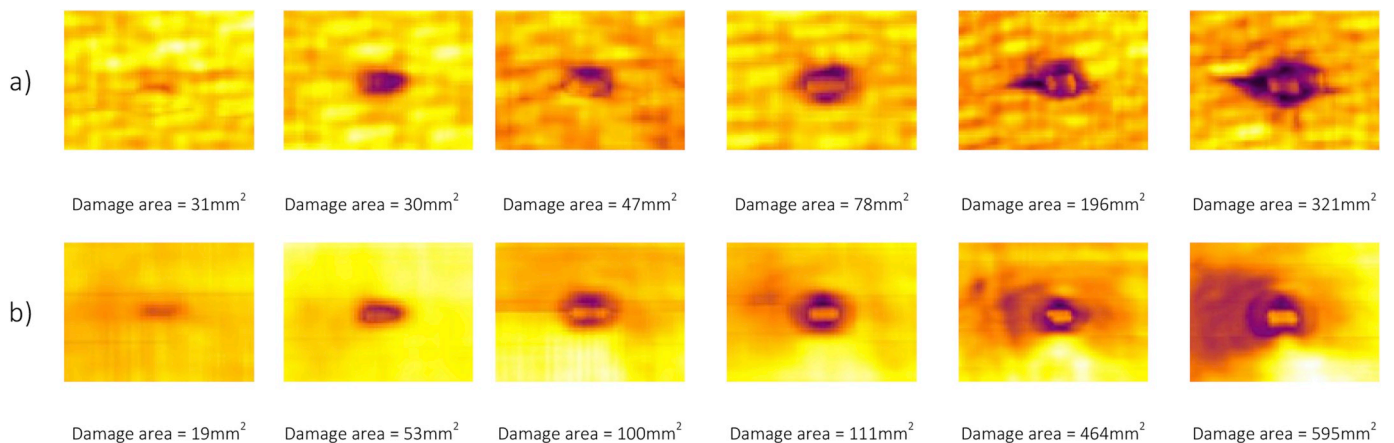
Fig. 6. C-scan images showing impact damage areas of a) the woven carbon fibre plates and b) the woven glass fibre plates under energy levels from low (left) to high (right).

Fig. 6 shows the C-scan images of the damage areas of the woven

plates under the six impact energy levels. The overall shape of the damage is elliptical. The impact damage is very small at low impact energy levels and may only be related to the local indentation. This is supported by the small hysteresis of the force-displacement curves shown in Fig. 5. The impact damage areas shown in Fig. 6a) are less than 10% of the delamination areas reported by Giannopoulos et al. [26] for the CFRP material with fire retardant resin for the same impact energy range. The difference could be related to the thickness, as the samples tested in Ref. [26] are 6.5 mm, and the fire retardant additives. The damage area shown in Fig. 6 increases with the impact energy. The damage area for the glass fibre laminate plate increases more quickly than that of the woven carbon fibre plate.

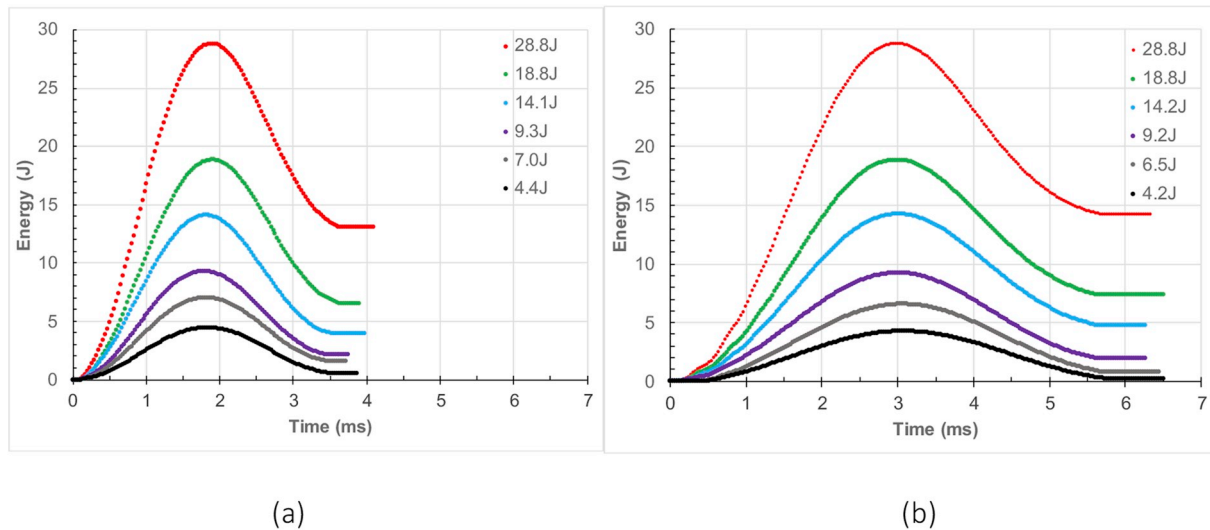
Fig. 7. Energy-time curves of: (a) woven carbon fibre and (b) woven glass fibre composite laminates.

Fig. 7 shows the energy-time histories of the woven composite laminate plates under low-velocity impact of the six energy levels. The energy absorbed by the composite laminates is represented by the difference between the initial impact energy and the kinetic energy of the impactor. The resulting plateau in the energy-time curve represents the energy absorbed by the composite laminates, and is primarily dissipated through the creation of damage.

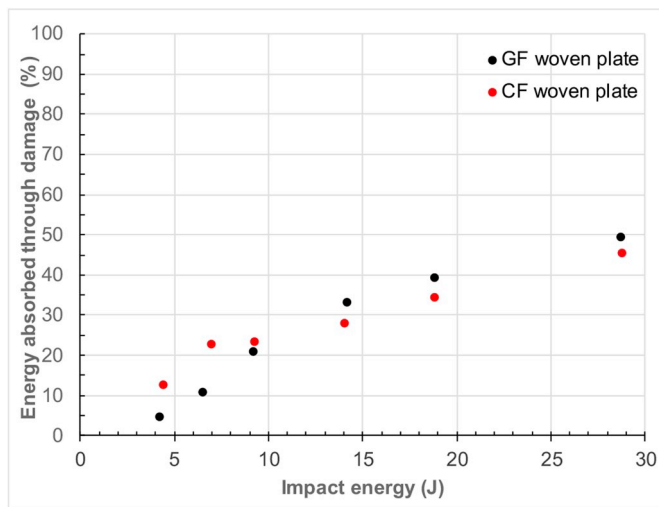
Fig. 8. Energy absorbed through damages as a percentage of the impact energy.

Fig. 8 presents the energy absorbed through damage shown in Fig. 7 as a percentage of the impact energy. The results are consistent with those shown in Fig. 7 and show that at lower impact energy, the carbon fibre woven plate absorbs more energy than the glass fibre woven plate. At high level of impact energy (>9J), the glass fibre woven plate absorbs more energy than the carbon fibre woven plate, indicating a possible change of the damage mechanism between the two woven plates as the impact energy increases.

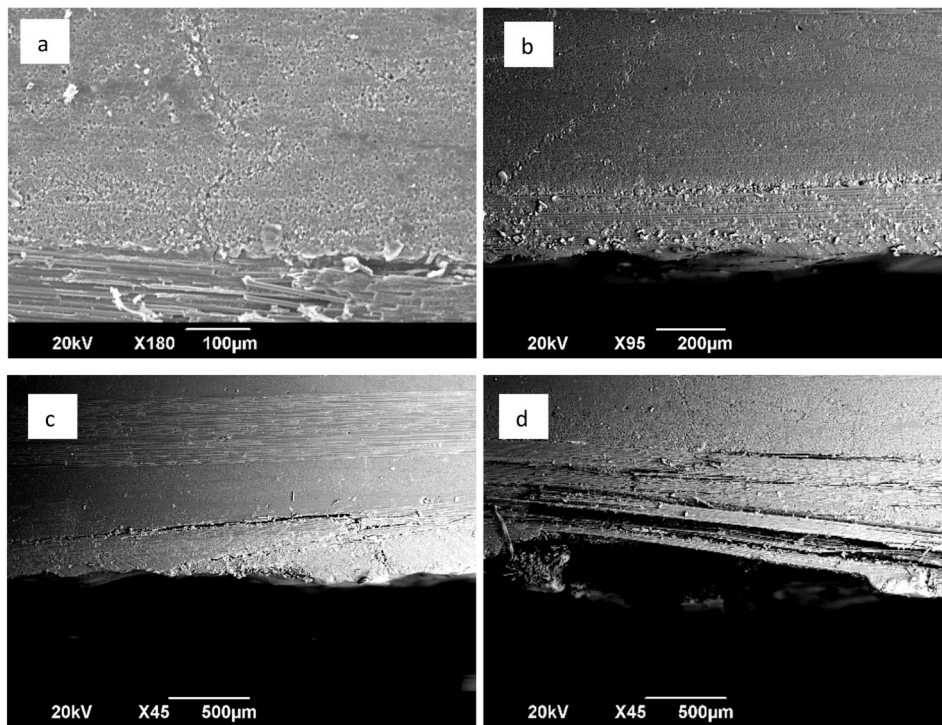
Fig. 9. SEM of the cross section of carbon composite plate tested at a) 15J, b) - c) 20J and d) 30J.

In Fig. 9, cross-sections of the carbon composite samples tested at 15J, 20J and 30J are shown. Matrix cracking is the first damage mechanism to be observed (Fig. 9a) and is associated with the damage at

the interface between the fibres and the matrix from where the crack initiates. The matrix cracking observed at 15J is also observed at 20J (Fig. 9b) along with more extended damage at the interface and in-between the layers (Fig. 9c). However, at higher-impact energy there is a higher deflection and most of the damage is located at the back-side

of the plates. The higher deflection causes the back-side to be subjected to higher membrane strain resulting in fibre fracture and damage between adjacent layers (Fig. 9d). The damage sequence observed in this work is consistent with that reported by Giannopoulos et al. [26]. At low impact energy the main damage is matrix cracking whilst at higher energy extended matrix cracking and fibre fracture is observed.

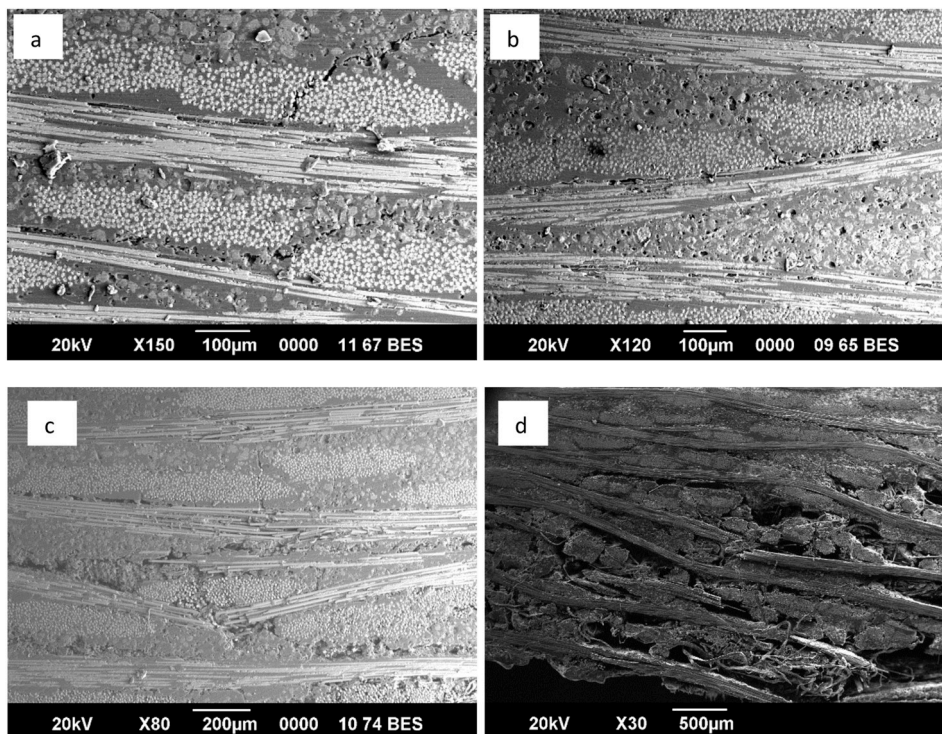
Fig. 10. SEM of the cross section of glass composite plate tested at a) 7J, b) 10J c) 15J and d) 30J.

SEM performed on the glass fibre composites shows that the damage appears at a lower impact energy compared to the carbon fibre composites (Fig. 10a). In particular it is possible to identify three distinct levels in the sequence of the damage mechanisms. The first level only involves matrix cracking, the second level is a combination of matrix cracking and fibre fracture and the third level is characterised by extended damage on the back-side.

The damage initiated at the interface between the fibres and the matrix (Fig. 10a) and propagated within the matrix following the fibres (Fig. 10b) and the fibre bundles. The membrane stress acting in each layer stretched the fibre bundles pushing the bundles against each other, producing a closure effect. For this reason the cracks developed in the

matrix did not propagate between the bundles. At the higher-impact energy level the tension in the fibre bundles will act as a localised load on the bundle in contact (Fig. 11) due to the woven architecture and membrane stress associated with the higher deflection. Moreover, the higher deflection increased the strain in the fibres which act with the localised load, resulting in a higher contact force at the interface between fibre bundles (Fig. 10c) which in turn promoting fibre fracture.

The fibre damage together with the shear strain at the interface between fibres and the matrix promotes the propagation of matrix cracks and leads to further damage at the fibre-matrix interface. At the highest impact energy level considered in this work (30J), an extended damage at the back-side is observed (Fig. 10d). Fibre fracture within several layers from the bottom face together with matrix damage has been observed.
