An investigation of the accelerated thermal degradation of different epoxy resin composites using X-ray microcomputed tomography and optical coherence tomography

Epoxy resin composites reinforced with hollow glass microspheres, microlight microspheres, 3D parabeam glass, and E-Glass individually were subjected to accelerated thermal degradation conditions. X-ray microcomputed tomography (X μ CT) was used to evaluate density changes, reinforcement filler damage, homogeneity, cracks and microcracks in the bulk of the different epoxy resin composites. X μ CT 3D images, 2D reconstructed images and voids calculations revealed microspheres damage, filler distributions and showed cracks in all composites with different shapes and volume in response to the thermal degradation conditions. In addition, expansion of air bubbles/voids was observed and recorded in the microsphere and microlight epoxy composite samples. In a complementary way, optical coherence tomography (OCT) was used as a novel optical characterisation technique to study structural changes of the surface and near-surface regions of the composites, uncovering signs of surface shrinkage caused by the thermal treatment. Thus, c

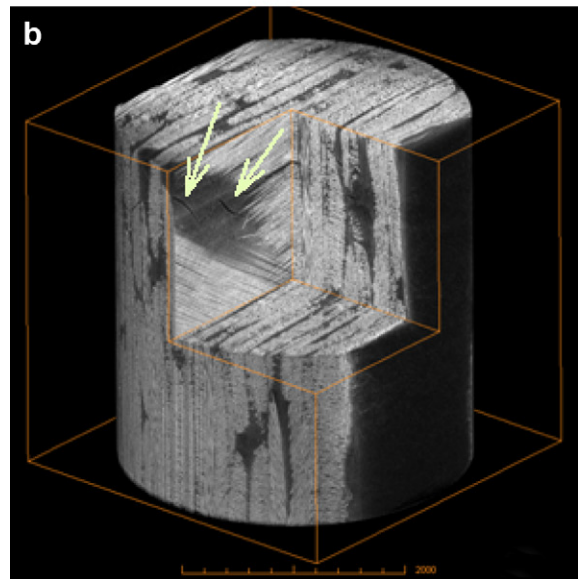
Fig. 11. Slice views of treated (240 °C, 30 h) E-Glass composite sample (a) and a three-dimensional view of some cracks inside the E-Glass resin sample (b) and its rendering volume (c).

Fig. 11a shows the 2D slices of the treated E-Glass resin composite treated at 240 °C for 30 h. In the E-Glass resin composite voids were generated mainly in the resin matrix between the fibre fabrics, similar to the voids in the 3D-Glass composite. As explained above (see also Table 1), E-Glass composites showed the least crack volume among tested composites. Further, it is observed that the E-Glass resin composite cracks form clusters of small voids. A 3D view of the cracks formation is presented in Fig. 11b. Fig. 11c shows the rendering image of the crack volume of the E-Glass composite at 240 °C and 30 h. Since the resin matrix system and the sample thickness of the 3D-Glass and E-Glass composites are the same, the
