Comparison study of dicyandiamide-cured epoxy bonded steel joints and polyamidoamine-cured epoxy bonded steel joints

Abstract

Keywords: B. Steel; Underwater repair; Epoxy; Three-point flexure; Interfacial shear strength; Dicyandiamide; Polyamidoamine

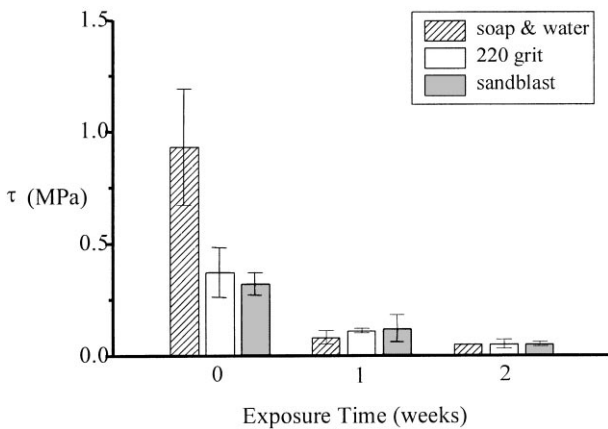
Fig. 5. Average interfacial shear strengths of EPON® 828/DICY-bonded joints in 3.4% NaCl solution (the error bars represent \pm one standard deviation).

The shear strength results for the EPON® 828/DICY-bonded joints that were aged in distilled water and in 3.4% NaCl solution are shown in Figs. 4 and 5, respectively and are summarized in Table 2. The maximum value calculated for axial stress of epoxy at failure was 34 MPa. The reported value for the tensile strength of the cured epoxy resin is 70 MPa [11]. Thus, the axial stress in the resin when the interface failed, was less than its tensile strength. This calculation confirmed the observation that the failure mechanism of the epoxy-bonded joints resulted from delamination of the epoxy from the

The average shear strength of the control group with steel scrubbed with soap and water was calculated to be 0.93 MPa. This value decreased to 0.46 and 0.05 MPa after one and two weeks of exposure in distilled water, respectively. After similar aging times in 3.4% NaCl solution, the average shear strength decreased more precipitously to 0.08 and 0.03 MPa. After just one week of aging in either environment, the bonded joints had lost most of their initial shear strength. It was observed that the bonded joints performed better in distilled water than in 3.4% NaCl solution.

The average shear strength of the control group with the sanded steel at the interface was 0.37 MPa. The average shear strength decreased to 0.14 and 0.06 MPa after one and two weeks of exposure in distilled water. With similar aging in saltwater, shear strength was reduced to 0.11 and 0.03 MPa. The bonded joints had again lost most of their original strength with the residual strength of the bonded joints still higher in distilled water.

The average shear strength of the control group with the sand-blasted substrate was 0.32 MPa. The average shear strength decreased to 0.12 and 0.08 MPa after one and two weeks of aging in distilled water. In saltwater shear strength was reduced to 0.12 and 0.03 MPa. It was again observed that the bonded joints lost most of their initial shear strength during the aging cycle and the saltwater was more detrimental to joint strength.

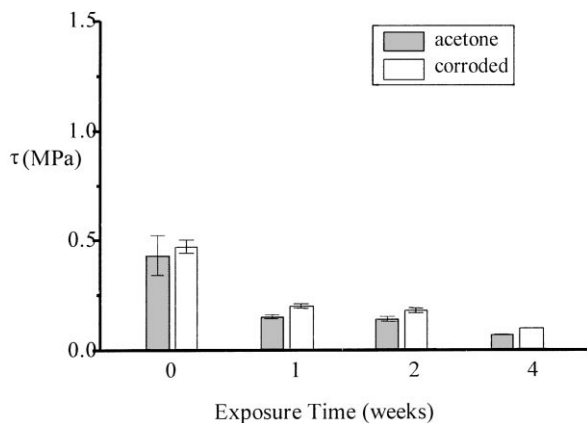
Fig. 7. Average interfacial shear strengths of EPON® 828/ EPI-CURE® 3090-bonded joints in 3.4% NaCl solution at 500C (the error bars represent \pm one standard deviation).

The shear strength results for the EPON® 828/EPI-CURE® 3090-bonded joints, aged in distilled water and in 3.4% NaCl solution, are shown in Figs. 6 and 7, respectively, and are summarized in Table 3. The maximum axial stress in the resin as the sample failed was 14 MPa, less than the resin tensile strength of 70 MPa [11]. This further confirmed the observation that failure resulted from delamination of epoxy from the substrate. If the axial stress exceeded the tensile strength, the epoxy would have failed in tension instead of delaminating from the substrate.

The average shear strength of the control group for the corroded substrate was calculated to be 0.47 MPa. The average shear strength decreased to 0.19, 0.15 and 0.12 MPa after one, two and four weeks of aging in distilled water and declined to 0.20, 0.18 and 0.10 MPa after similar times in saltwater. The difference in shear strength loss was not statistically significant between the environments.

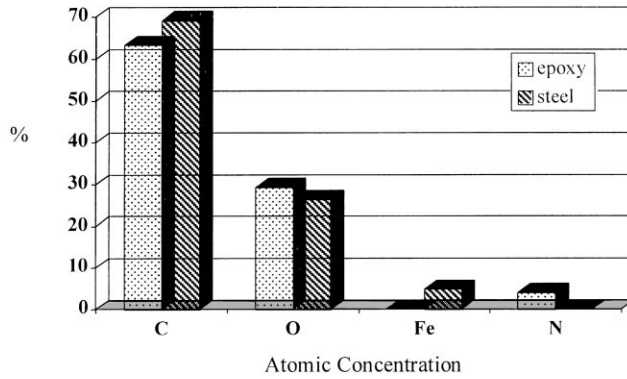
Fig. 8. XPS results for EPON® 828/ EPI-CURE® 3090 bonded on acetone-wiped steel.

The failed surfaces of the EPON® 828/DICY-bonded joints were examined by optical microscopy. It was observed that the failure occurred cohesively within the oxide layers. The failure surfaces of the EPON® 828/EPI-CURE® 3090-bonded samples were also analyzed by XPS. The results are shown in Fig. 8 for the epoxy-bonded acetone-wiped substrate and Fig. 9 for the epoxy-bonded corroded substrate.

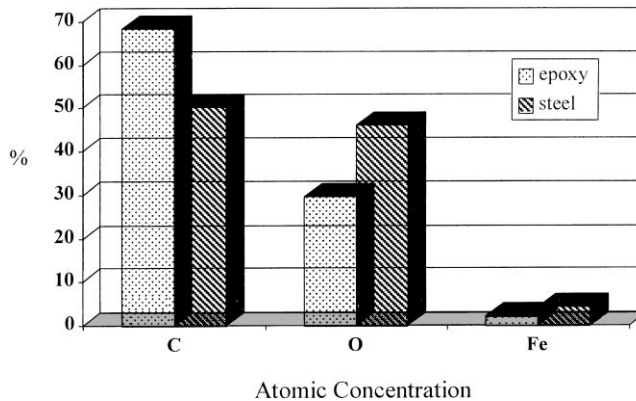
Fig. 9. XPS results for EPON® 828/ EPI-CURE® 3090 bonded on corroded steel.
